## **Exhibit K**

**PHASE I INSPECTION REPORT  
NATIONAL DAM SAFETY PROGRAM**

**CAMP KWONEESUM DAM  
SKAMANIA COUNTY, WASHINGTON  
WA-131**

CH2M HILL  
BELLEVUE, WASHINGTON  
OCTOBER, 1979

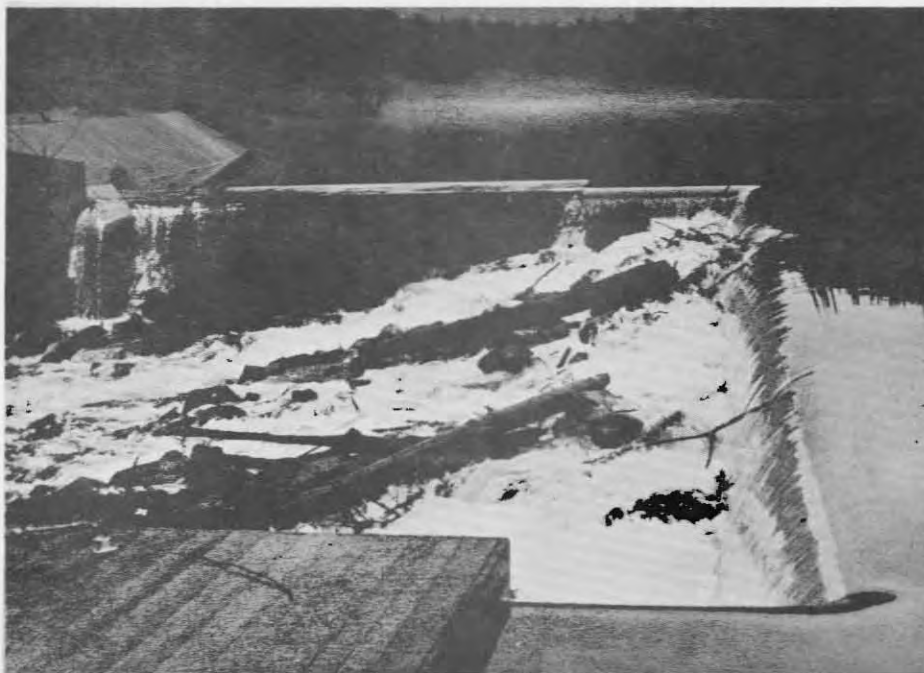
[PHOTO 1] Spillway Weir Wall

The spillway weir wall could fail as the riprap support along the downstream face of the weir wall is removed by large discharges. This failure will not endanger the dam or cause significant downstream damage, but may reduce the recreational value of the project.

will be displaced, possibly removing support for the concrete weir wall, at discharges less than maximum spillway capacity. It is not likely that failure of the wall will endanger the dam or cause significant downstream damage. However, failure of the wall at low discharges could create a sudden surge of flow in the creek and could endanger lives. Part of the spillway channel wall also serves as the left abutment retaining wall for the rockfill. Stability of this retaining wall is discussed in paragraph 2.3.3.

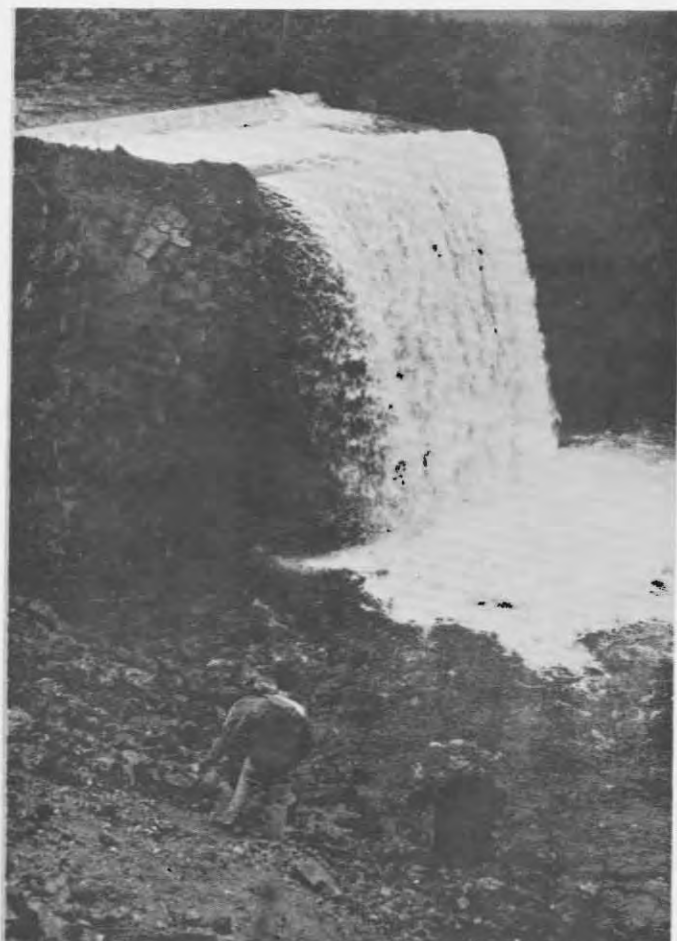
[PHOTO 2] Spillway  
Plunge Pool

The discharge to the pool has undercut the rock cliff at the pool level. Continued undercutting will not likely affect dam safety. The ridge between the discharge channel and the dam is not high enough to confine maximum spillway discharges to the exit channel. Preliminary analysis indicates this wall may be overtopped at discharges less than one-half of maximum flow, causing water to impinge on the face of the dam. This condition could remove material from the downstream face of the dam near the toe, and lead to instability and possible failure of the rockfill embankment.

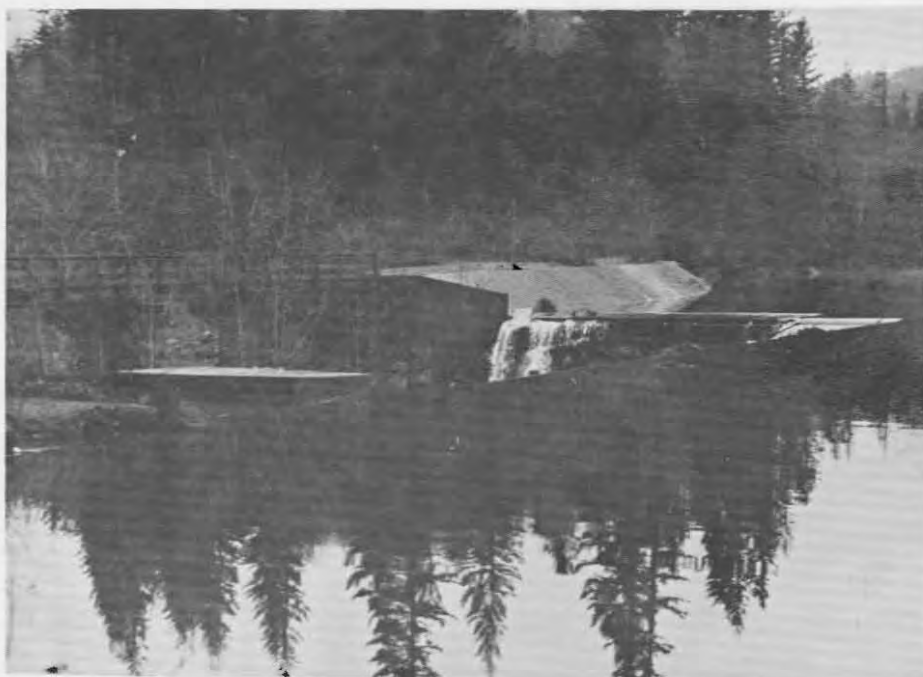
[PHOTO 3] Left Abutment at Spillway

The spillway for Camp Kwoneesum Dam is an uncontrolled structure founded in rock at the left abutment (Plates 5 and 6). The 160-foot-long weir (elevation 947 feet NGVD) is an 8-inch-thick concrete wall. Riprap makes up the 1 V on 3 H sloping downstream face of the weir. The upstream side of the weir wall has been backfilled to elevation 945 feet NGVD (2 feet below the top of the wall). The alignment of the weir is such that two 40-foot lengths are perpendicular to the ends of an 80-foot section. (see Photo 1). Flow over the weir wall enters a trapezoidal discharge channel having an invert elevation of 936 feet NGVD with 1 V on 3 H side slopes and 26-foot bottom width. A bridge, with 3 piers, crosses the discharge channel at the dam axis. At this point the side slopes of the discharge channel change to 1 V on 2 H providing a 34-foot bottom width. Approximately 36 feet downstream from the bridge, the channel makes a 30 degree bend toward the dam. A 3-foot-high wedge-shaped rock berm has been placed in the channel at the bend for flow control. Approximately 60 feet downstream of this bend, a 2-foot-high concrete weir (Plate 5) (approximate elevation 937 feet NGVD) crosses the discharge channel. About 20 feet downstream beyond this weir the spillway discharge drops vertically over a rock face for 35 feet to the pool at the toe of the dam (see Photo 2). A concrete lip at the brink springs the flow away from the rock face to discharge directly to the pool. Concrete has been placed along the right side of the discharge channel between the weir and the concrete lip to direct the flow.

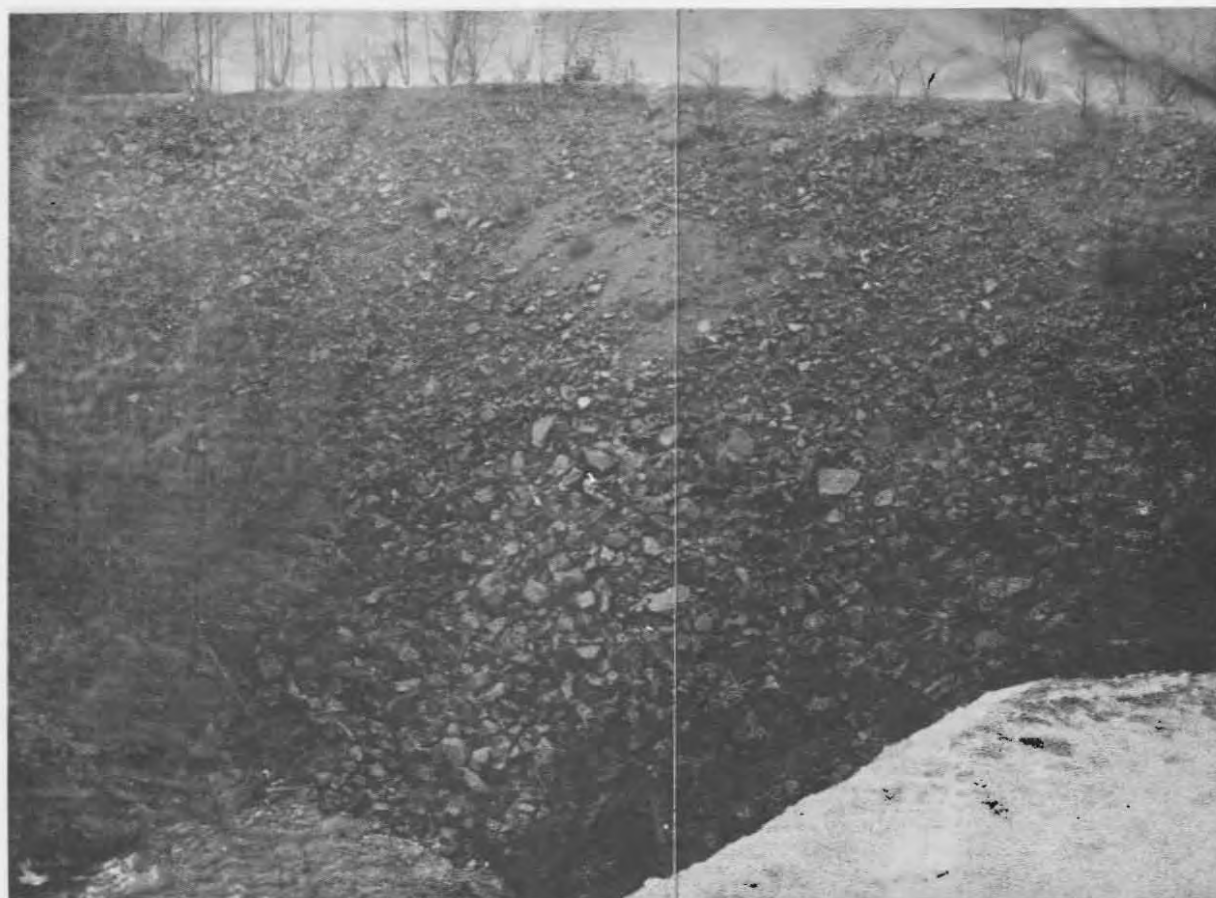
[PHOTO 4] Downstream Slope

Alder trees 2 to 6 inches in diameter exist on the crest of the dam, mainly between the rockfill embankment and the spillway. The downstream slope surface is almost entirely free of vegetation and showed no signs of movement. Coarse rock was located on the lower portion of the slope and finer rock exists near the crest (Photo 4). This condition appears to be segregation as a result of dumping material from the dam crest. As the bulk of the dam was not constructed in this manner, the downstream slope or embankment should not be adversely affected by this condition.

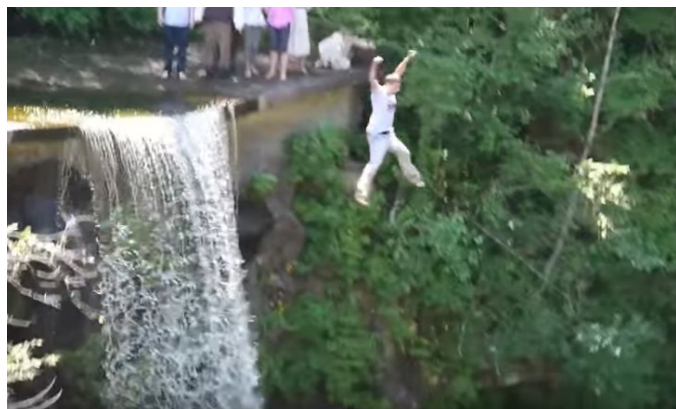
*Figure 9, Screen capture from <https://www.youtube.com/watch?v=4jtaczu2GFU>*

Public access to the structure itself creates a potential for injury or death. The plunge pool beneath the dam spillway is an attractive nuisance where some visitors take the 30-foot plunge off the spillway (Figure 9).
